THE AUSTIN HOME INSPECTOR

6903 Sample Cove
Austin, TX 78731
01/16/2017

Report Type: Foundation Assessment and Relative Height Survey
Property Lead Inspector: A. Jordan #9458

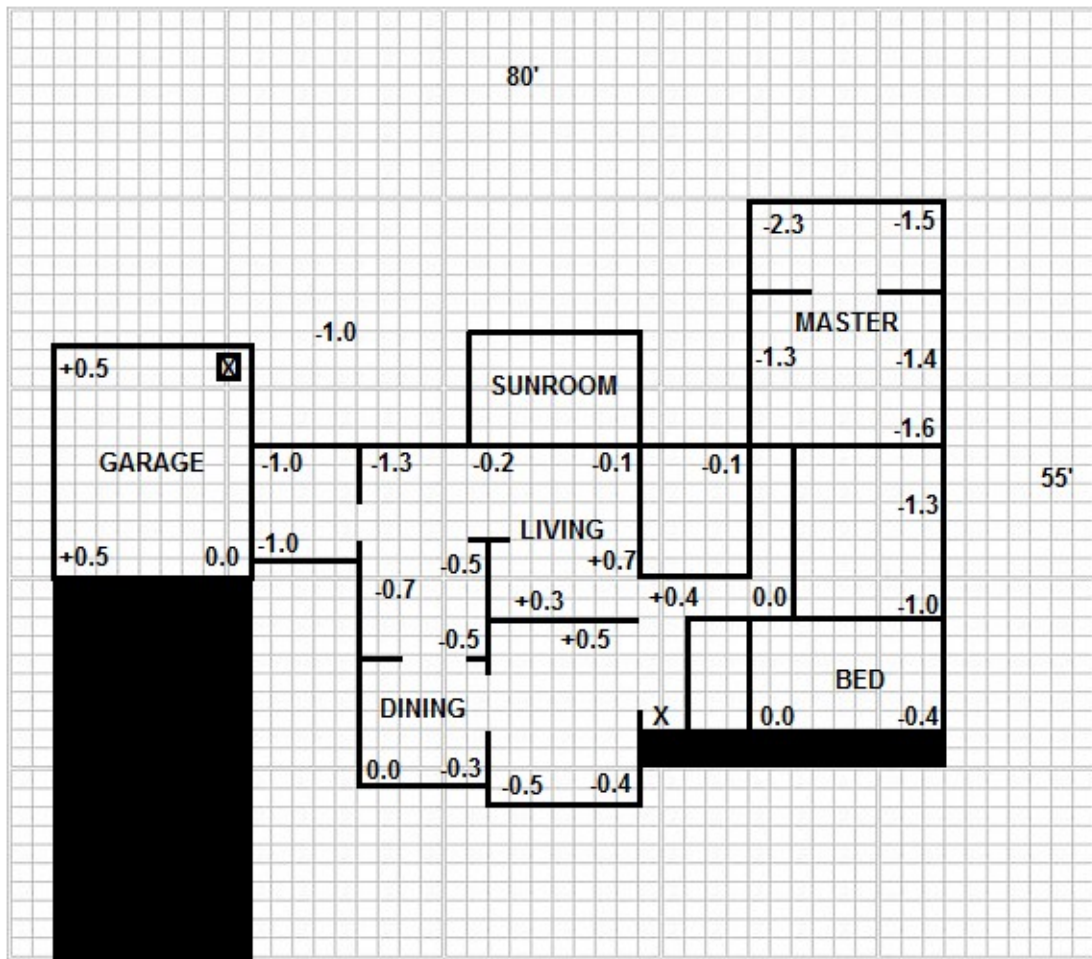
INTERIOR ELEVATIONS

The following drawing shows the raw measurement data taken during the inspection of the property. The measurements are shown on an engineering scale in tenths of an inch. All readings indicate a difference in elevation relative to the reference point, which is indicated by the '⊠' symbol. The exterior numbers represent approximate linear footage. The drawing is not to scale, but is a reasonable facsimile. The drawing should only be used as a reference tool:

The visual analysis of the structure and foundation did not reveal indicators associated with distinct foundation failure. Evidence of minor-moderate phenomena (structural damaged caused by settlement) was noted. Relative height differences recorded by foundation surveying equipment (ZipLevel Pro) indicate that settlement has occurred. Higher than typical survey readings may be due, in part, to the unique design and slab layout of the structure. The survey information correlates with visual indicators. In this inspector's professional opinion, the structure is currently supported by the foundation to an adequate degree. Noted evidence of structural damage caused by settlement appears to be minimal and, for the most part, cosmetic in nature. Ensure that the home is properly maintained and updated as needed. Any recommendation or concerns noted in associated reports should be addressed by skilled professionals. If further evaluation or verification of these findings are required, a structural engineer should be contacted.
