Property: Sample Copy
Austin , TX 78731
Client: Sample Copy
Inspector: Andy Jordan #9458
Date: September 13, 2016

PROPERTY INSPECTION REPORT

Concerning: Sample Copy Austin , TX 78731
(Address or Other Identification of Inspected Property)

By: Andy Jordan, Lic #9458 September 13, 2016
(Name and License Number of Inspector) (Date)

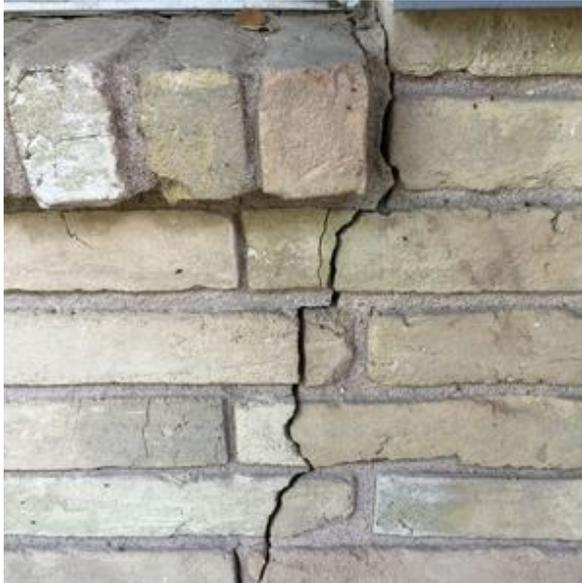
The visual analysis of the structure and foundation did not reveal indicators associated with excessive foundation movement and failure. Evidence of moderate phenomena (structural damage caused by settlement) was noted. Relative height differences recorded by foundation surveying equipment (ZipLevel Pro) indicate that settlement common to the structure's location, type, and age has occurred. The survey information correlates with visual indicators (primary source of evaluation). In this inspector's professional opinion, the structure is currently supported by the foundation to an adequate degree. Noted evidence of structural damage caused by settlement appears to be, for the most part, cosmetic in nature. Ensure that the home is properly maintained and updated as needed. Any recommendation or concerns noted in this report should be addressed by skilled professionals. If further evaluation or verification of these findings are required, a structural engineer should be contacted. A site drawing and readings have been recorded and filed. Survey drawings are available by request or per the scope of work.

SETTLEMENT CRACKS - MONITOR

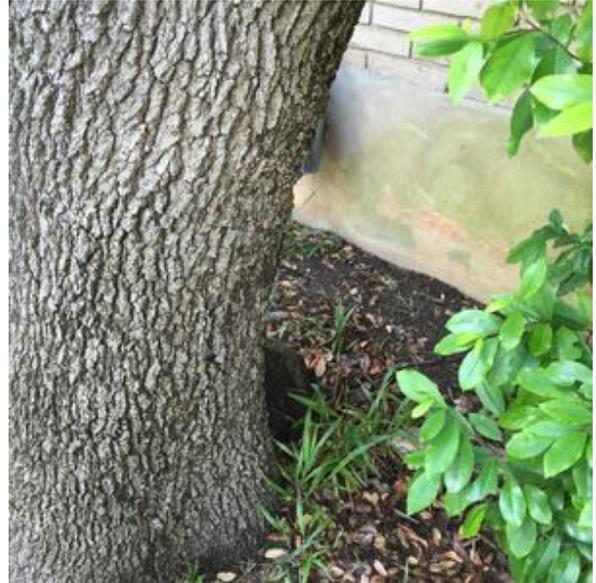
Large trees were noted as being near the main structure. Trees and their associated root systems can affect a structure through direct contact, root activity, and/or moisture absorption. Ensure the tree remains trimmed back to avoid direct damage. Consulting with an arborist may aid in determining if additional improvements or adjustments are warranted.

TREE NEAR STRUCTURE

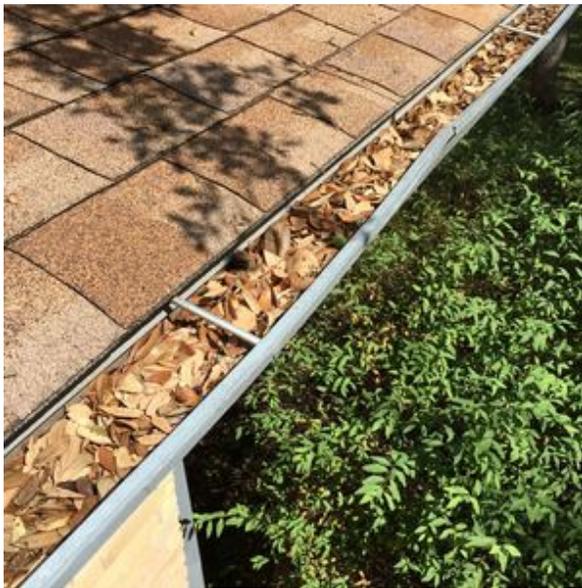
- COMMON GUTTER MAINTENANCE AND UPDATES REQUIRED:
Common adjustment and general servicing needs were noted throughout the rain gutter system. Contacting a gutter specialist is recommended to address common issues and maintenance needs.
- ISOLATED AREAS OF ELEVATED SOIL LINES:
Elevated soil lines were noted at the exterior walls (soil rises above foundation - contact w/ siding). High soil lines increase the likelihood of moisture damage and insect intrusion. General standards call for no less that 3" of foundation wall to be visible above all soil lines. Adjustments to the soil line should take place to properly protect the structure and reduce the likelihood of damage. Areas of elevated soil lines were noted in the following locations:
-Right Wall Garage

SERVICE GUTTERS

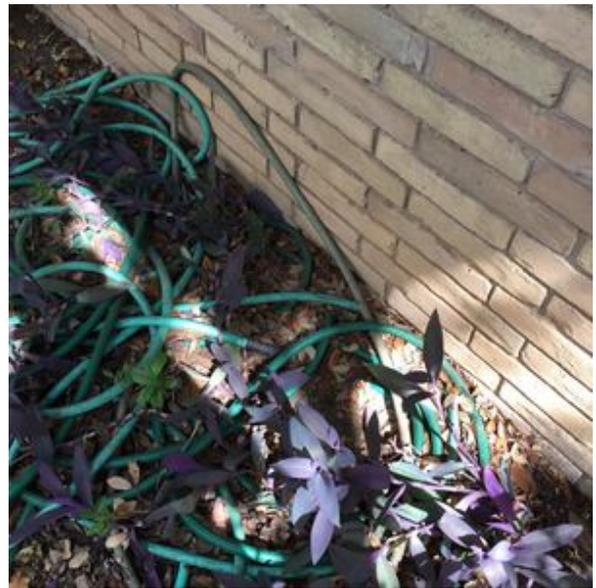
ADDRESS SOIL LINE (MINOR)

- Address High Soil Left Garage Wall: Reduce Soil Line to Eliminate Possible Moisture/Insect Issues
- General Maintenance Updates Required Throughout: Caulking/Sealing/Minor Repairs

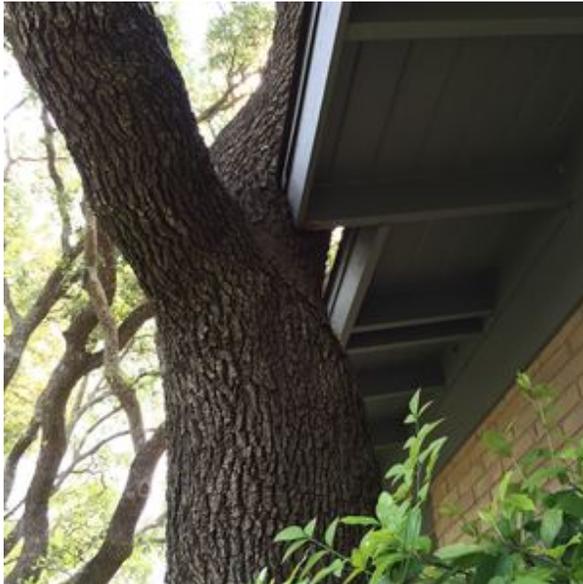
Current tree limb contact with the roof and structure was noted. At the time of inspection, no significant damage to roofing material was discovered, however, updates are required to prevent more significant damage at a future date. Tree contact with the roof and structure can lead to material damage in a relatively short amount of time. A tree specialist should address limb contact and make needed adjustments to surrounding trees/shrubs. Ensure updates and maintenance are addressed in an expeditious manner.

TREE CONTACT WITH STRUCTURE

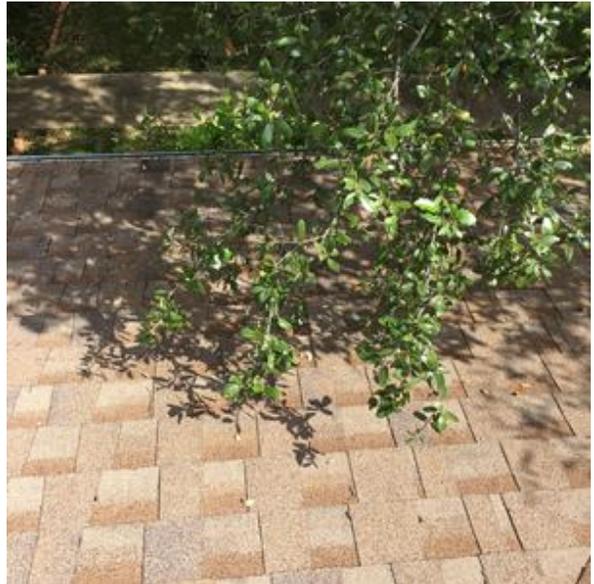
LIMBS NEARING CONTACT

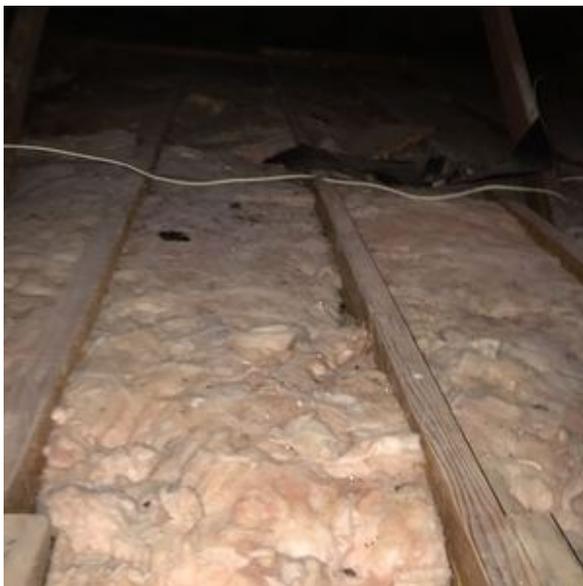
Areas of reduced insulation (by today's standards) were discovered in the attic at various locations. The redistribution or installation of additional insulation is recommended to improve the overall energy efficiency of the structure. The overall degree of reduced insulation is considered minimal for a structure of this age and type. Updates would be considered a general improvement.

INSULATION MEETS DATED STANDARDS

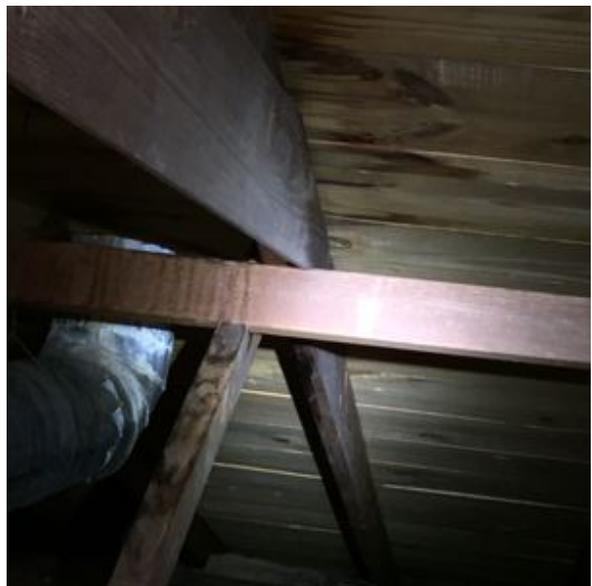
Evidence of previous moisture entry and minor sub-roof and/or framing material damage was noted at various roof exit points (vent/exhaust exits). At the time of inspection, the areas of noted moisture entry were visually assessed and tested with moisture metering equipment. Active leaks were not discovered during the site assessment. Ensure all needed caulking/sealing updates take place at the roof level. Regularly monitoring these areas (particularly after heavy storms) is recommended to ensure active leaks are not present.

PREVIOUS MOISTURE ENTRY (MINOR)

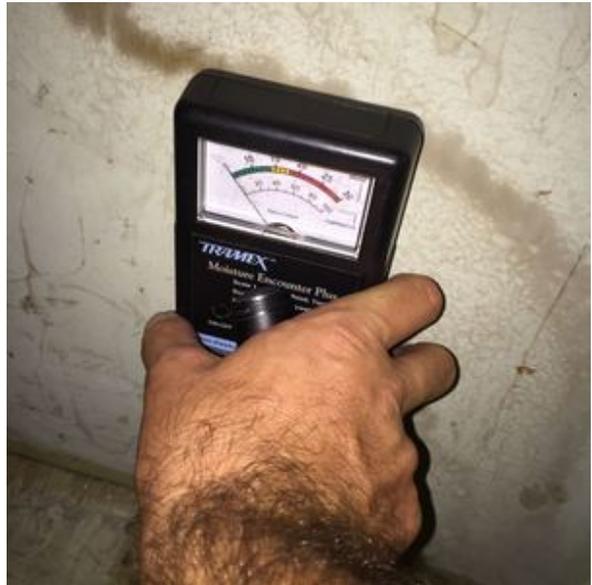
Previous moisture damage at the HVAC closet wall was noted. Additional testing for elevated moisture levels were conducted (Tramex Moisture Encounter). At the time of inspection, moisture levels in this area were within normal levels. Ensure this area is monitored per general maintenance guidelines.

NORMAL LEVELS HVAC CLOSET

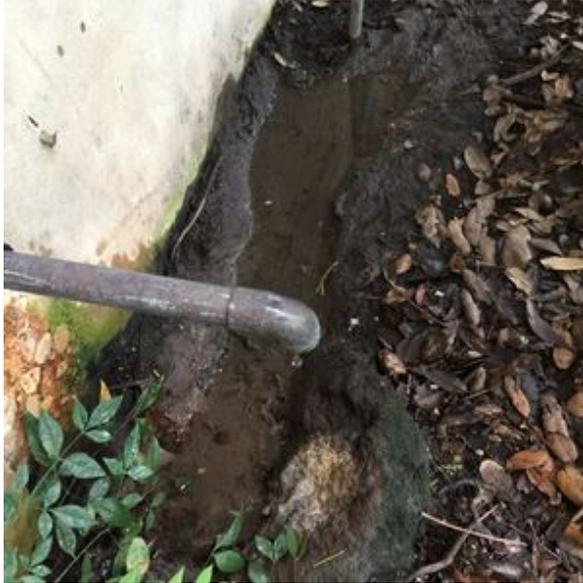
A system drain line (HVAC) is releasing moisture on and around the structure foundation. Updates to the drain line are required to prevent excess moisture issues.

DRAIN LINE UPDATES NEEDED

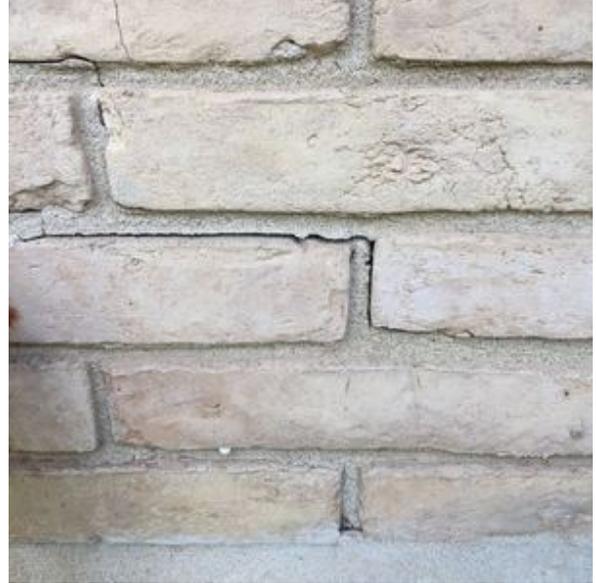
-Monitor Settlement Cracks at Various Locations: Ensure No Additional Settlement Cracks Occurring/Increasing

COMMON SETTLEMENT CRACKS

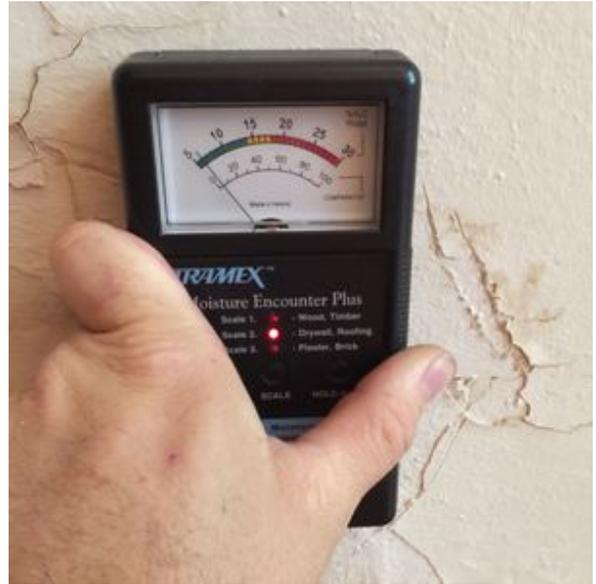
- PRIMARY CEILING MATERIAL: Drywall
GENERAL CONDITION: Meets Standards
The ceiling material is considered to be in generally fair condition. Minor flaws noted are consistent with the structure's age and type.
- PREVIOUS MOISTURE DAMAGE DISCOVERED:
Previous moisture damage at the ceiling (near fireplace) was noted. Additional testing for elevated moisture levels were conducted (Tramex Moisture Encounter). At the time of inspection, moisture levels in this area were within normal levels. Leakage in this area was likely addressed when the roof was replaced. Ensure this area is monitored per general maintenance guidelines.

NORMAL LEVEL AT PREVIOUS LEAK

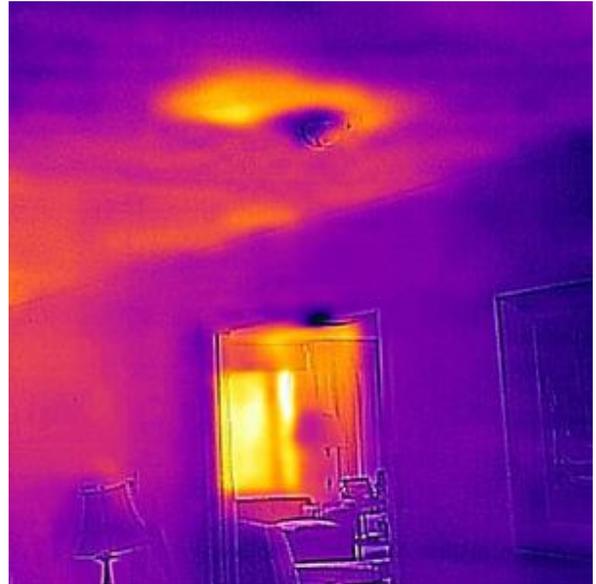
LOW INSULATION (OARNGE AT CEILING)

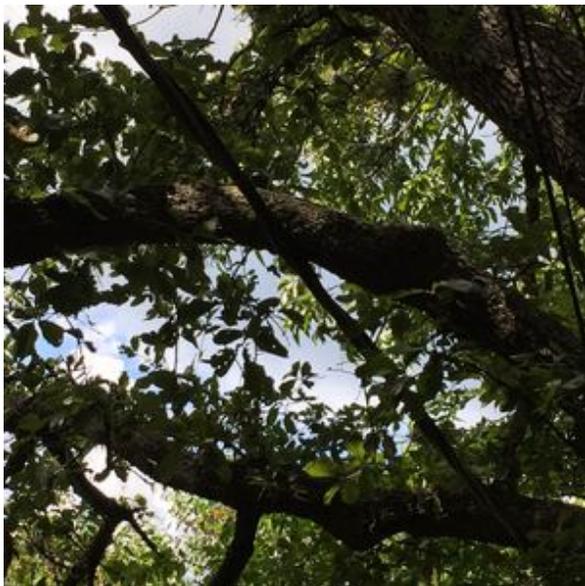
- TREE CONTACT WITH MAIN SUPPLY:
Contacting a tree specialist or the electric utility provider is recommended to address tree branches in contact with electrical supply wires. Ensure this issue is addressed to prevent safety hazards and/or functionality disruptions.
- REPLACE DAMAGED CONDUIT PLATE:
Replacement of a rusting and damaged conduit plate at the front exterior wall (near porch) is recommended to prevent moisture entry at this area.

TREE CONTACT WITH SUPPLY LINE

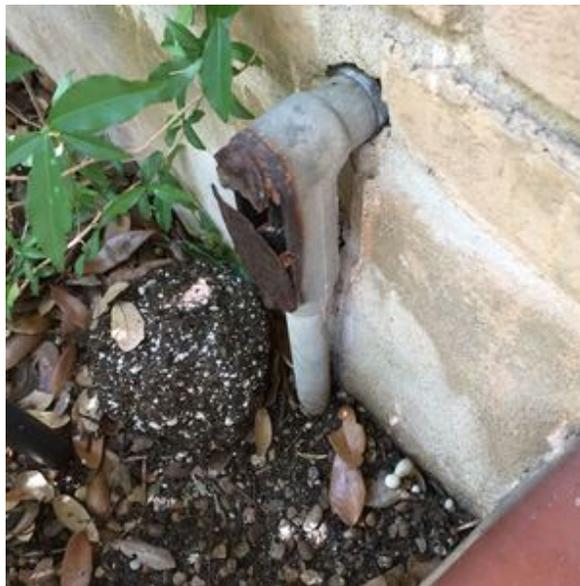
REPLACE CONDUIT PLATE

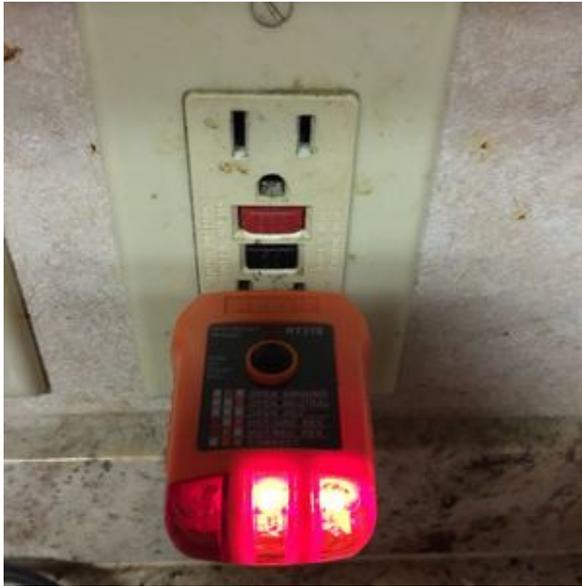
- SYSTEM UPDATES NOTED AT VARIOUS LOCATIONS:
Various key locations of the home have been updated to meet more recent electrical safety standards. Any additional updates would be considered an overall improvement to system safety and functionality. Consulting with a licensed electrician is recommended to determine what updates would best benefit the home.

PROPER SYSTEM UPDATES NOTED

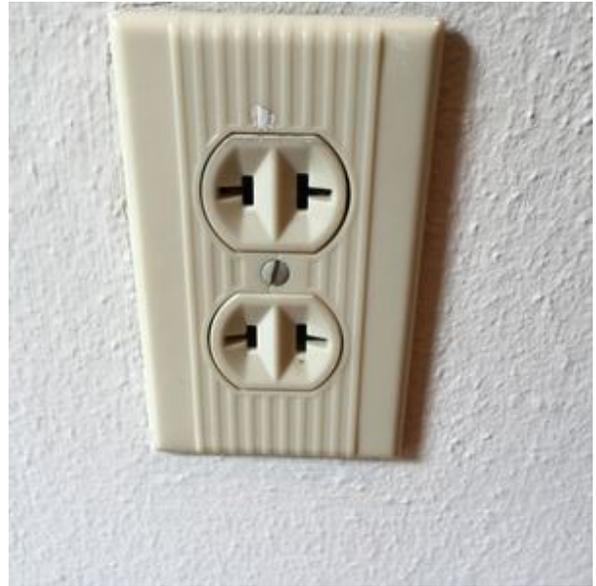
Most outlets throughout the structure are designed for ungrounded, two-prong electrical plugs. Replacing the dated outlets with three prong devices is recommended to improve system functionality. Any grounding updates to circuits would be considered a system improvement.

DATED OUTLETS

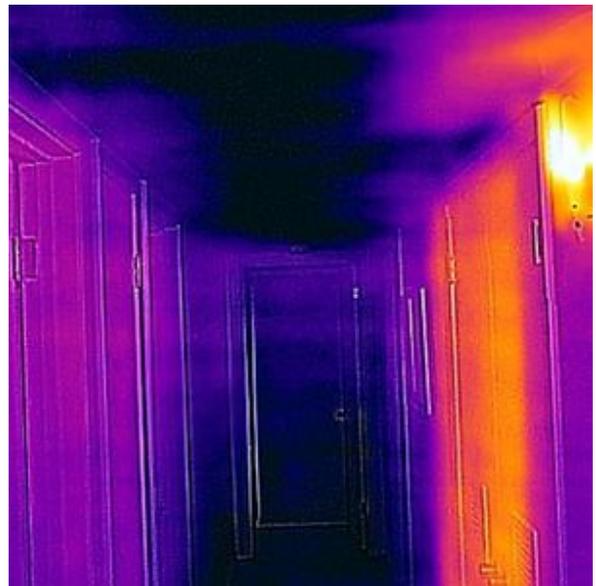
A partial thermal imaging analysis of the HVAC duct system was conducted during the inspection of the property. Areas of common air/energy loss was discovered during the limited test. The loss of air appeared to be consistent with the age of construction. Updating and servicing the duct system would be considered an improvement.

ENERGY LOSS HALL DUCT - THERMAL CAMERA

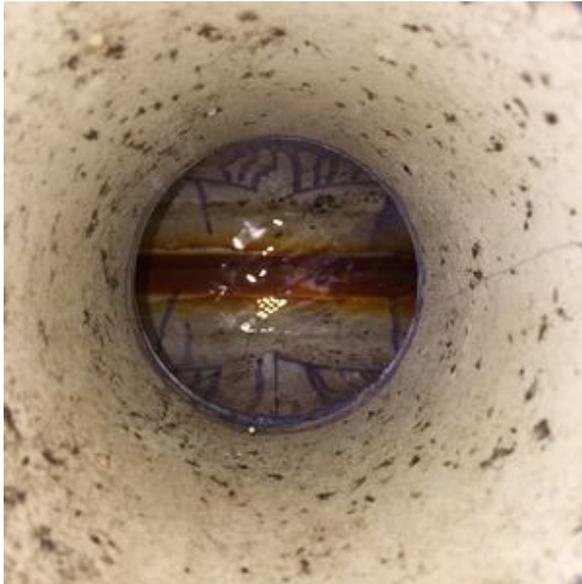
PROPER DRAIN FLOW/UPDATED PVC

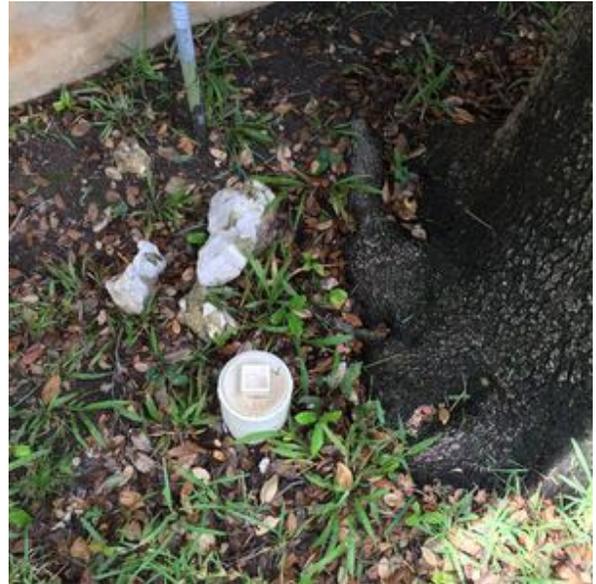
-Cast Iron Plumbing Present in Some Areas

-NOTE: No Evidence of Pipe Damage Discovered - Recommendation Based on General Observation

PLUMBING NEAR ROOT SYSTEM
