THE AUSTIN HOME INSPECTOR

On 08MAY2019, a site visit to the above mentioned property was made in order to perform a property assessment. A partial and limited assessment of the foundation and crawlspace was conducted at that time. Areas of concern and recommendations have been provided herein.

CRAWLSPACE ASSESSMENT

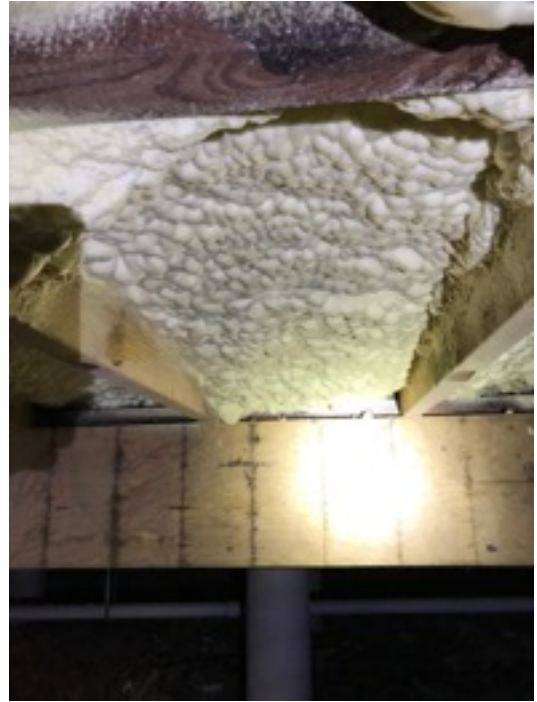
OPEN CELL FOAM INSULATION

Further investigation of the current condition of foam insulation located in the crawlspaces should be conducted by a subject matter expert to determine if removal is required. Updates to insulation should be conducted per the guidance of the contracted subject matter expert.

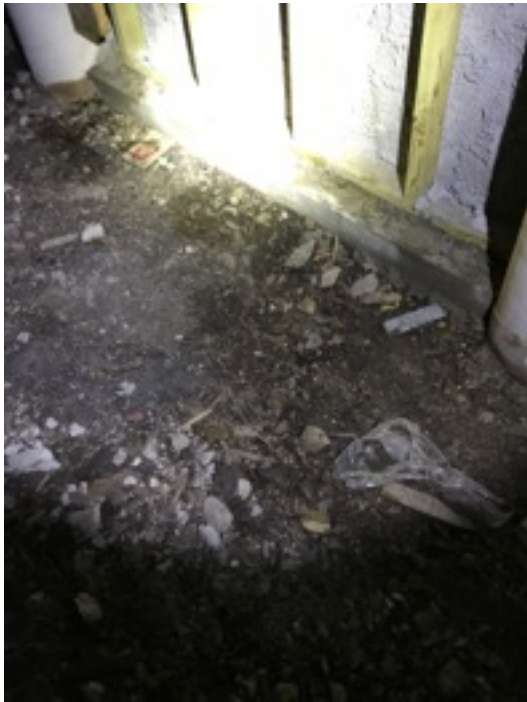
MOISTURE PENETRATION

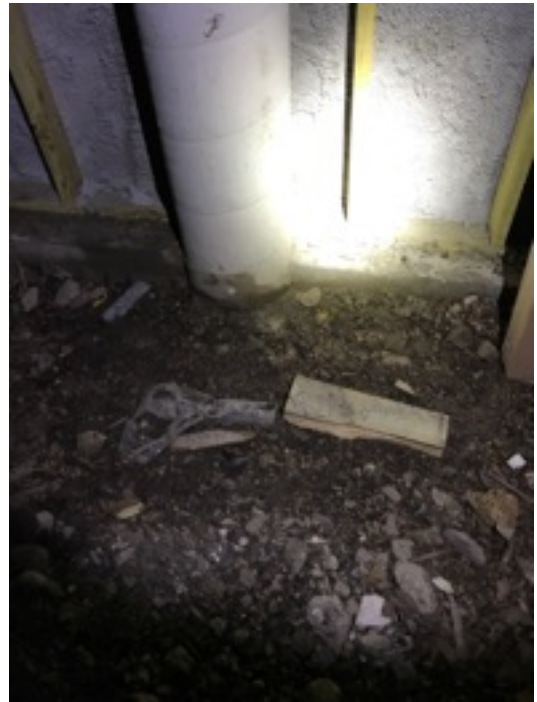
MOISTURE PENETRATION

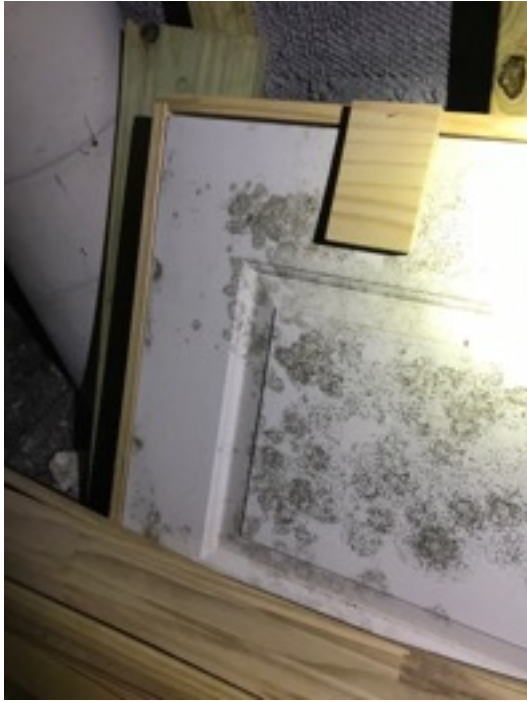
VISUALLY DISCOVERED MOLD

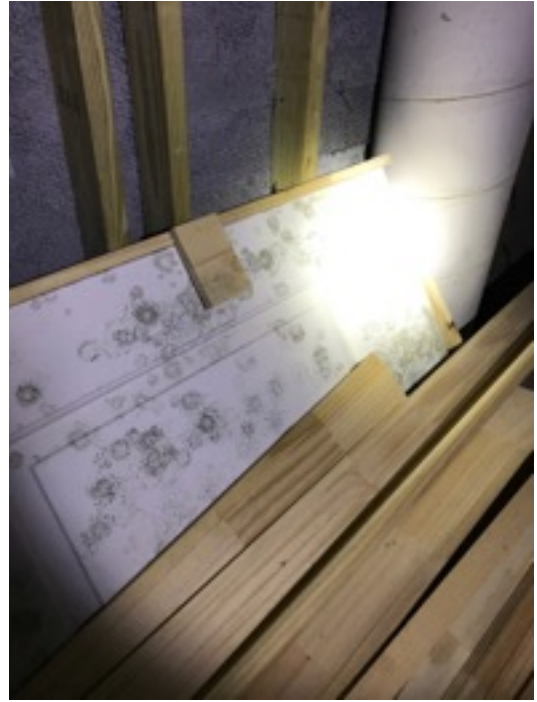
VISUALLY DISCOVERED MOLD

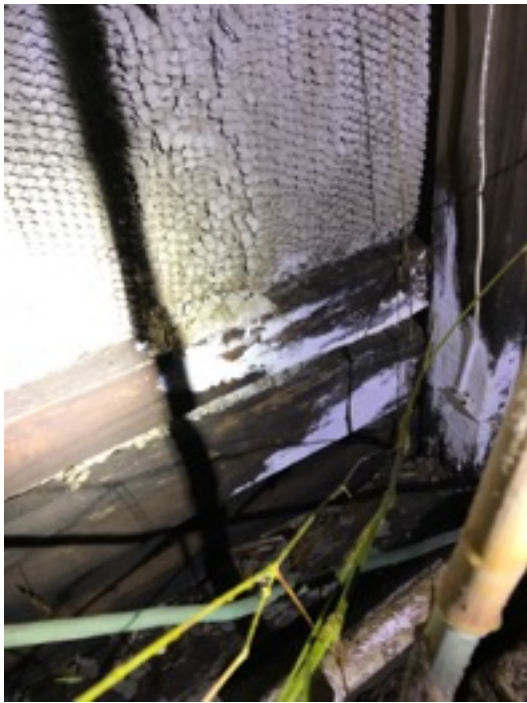
SUSPECT MOLD/FUNGAL GROWTH

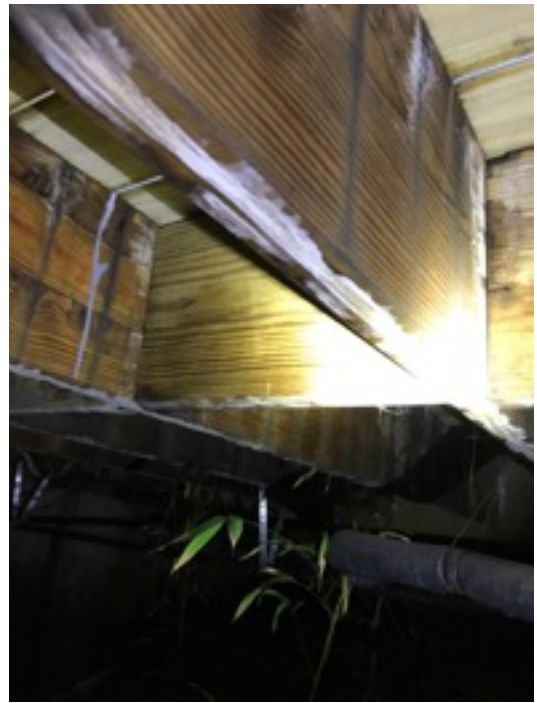
SUSPECT MOLD/FUNGAL GROWTH

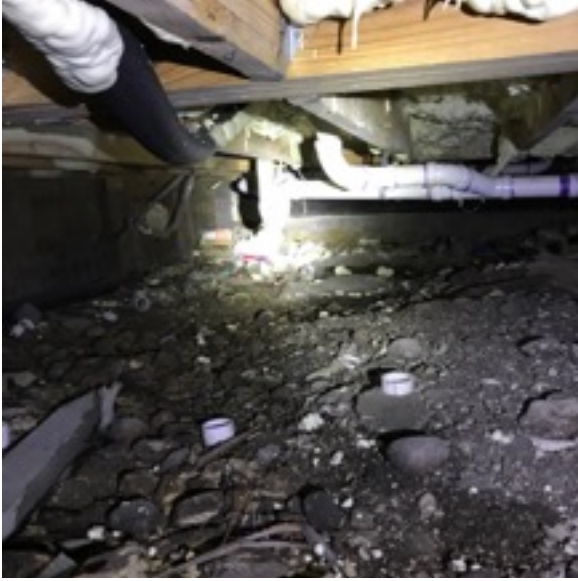
At the time of inspection, wood rot, suspect surface mold, and fungal growth was visually discovered within the crawlspaces (mainly at stored material, wood products, and soil surfaces). Excessive moisture accumulation was discovered at areas under the back deck, at the back corner (near center stem wall and plumbing) and at isolated portions of of the perimeter stem wall (throughout). A visual assessment and equipment readings indicated that humidity levels were well over recommended levels.

EXCESS MOISTURE AT BACK CORNER

Further action will be required to determine the best course of action to address problematic moisture and environmental conditions within the crawlspace. Following initial moisture remediation and repair, updates to grading drainage, moisture barrier protection, ventilation or encapsulation will be required. Additional inspections/testing during and after repairs and updates take place are advised.

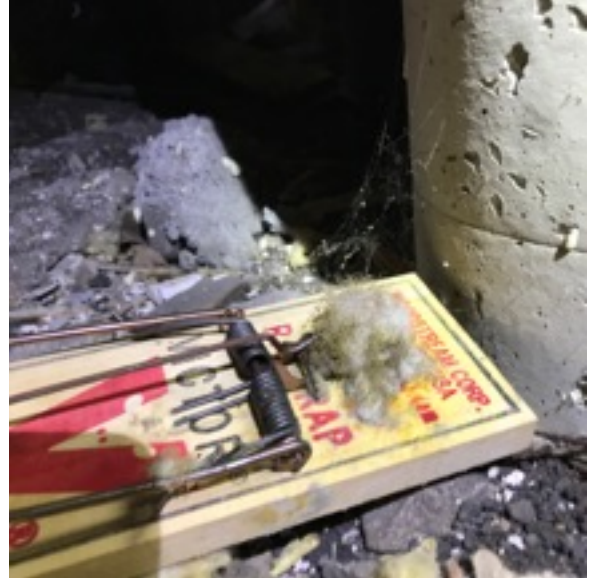
MOLD/FUNGAL GROWTH AT TRAPS

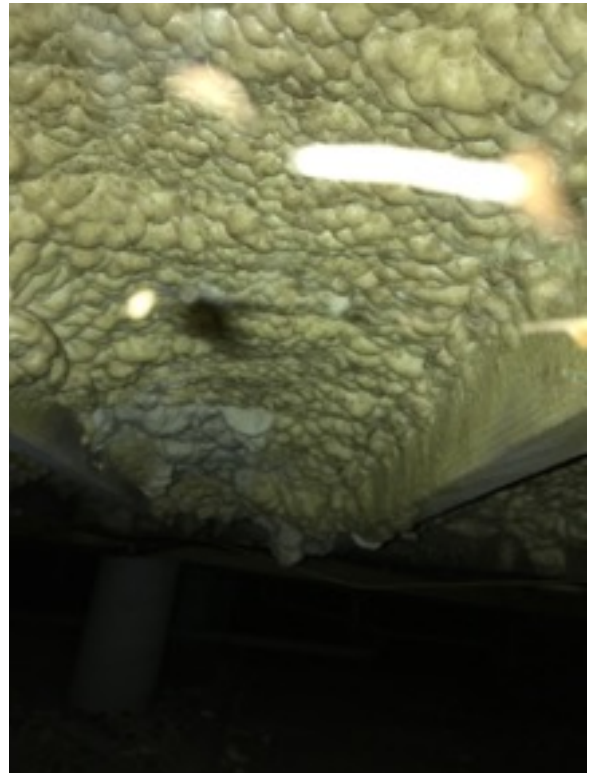
At the time of inspection, suspect mold was visually discovered within the crawlspaces (mainly at wood products, and the surfaces of open cell foam insulation). Excessive moisture accumulation was discovered at various portions of of the perimeter stem walls and throughout. A visual assessment and equipment readings indicated that humidity levels were well over recommended levels.

SUSPECT SURFACE MOLD
